Technical Memorandum

SUBJECT: **E03463, Supp. 7, Signal Prog. Support**
City of Reading TSAMS Use-Case Project
DRAFT Traffic Signal Maintenance Plan

City of Reading Traffic Signal Maintenance Plan

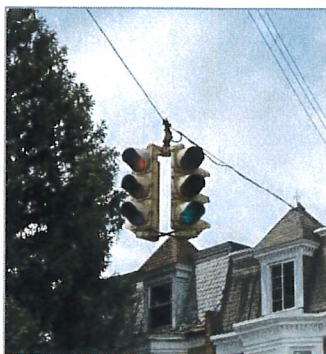
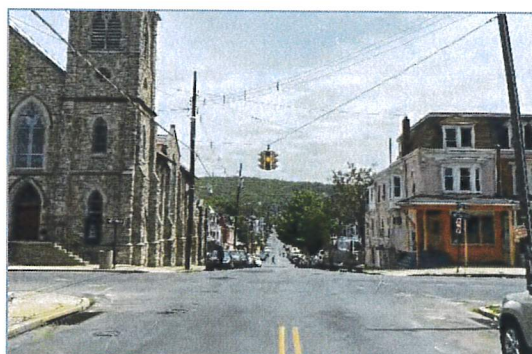
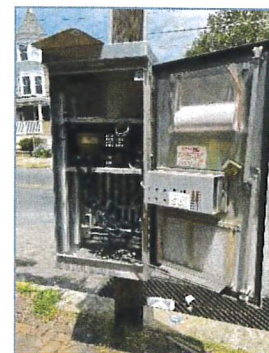
In this example, vehicle signal housing number 1 had faded paint and number 3 was missing a visor. Additionally, structure number 2 was rusty. See example images 1, 2, and 3 below.

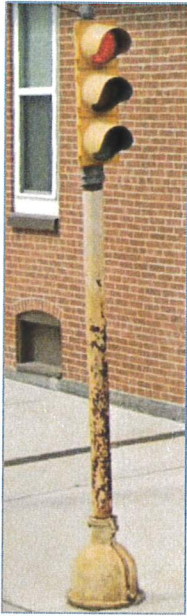
*Example Image 1 –
Rusted structure*

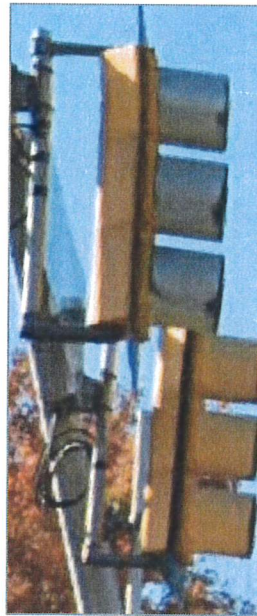
*Example Image 2 –
Faded vehicle signal housing*

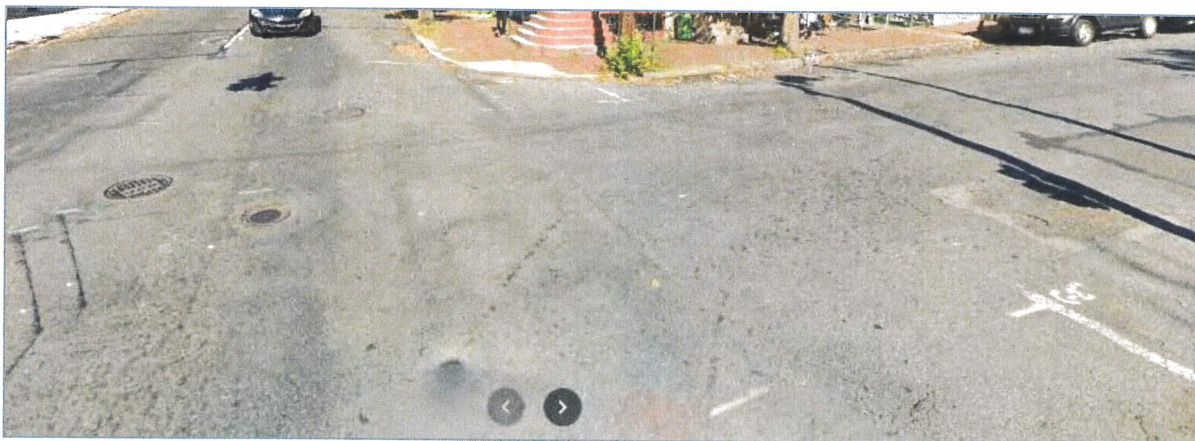
There were three subcategories of pavement markings either present or indicated on the permit. The crosswalk lines are very faded and almost nonexistent. Stop bars are missing from both approaches and the lane line is missing from the approach on the right of the image below. These factors led to all of these categories receiving a rating of 1.

Example Image 4 – Faded and missing pavement markings

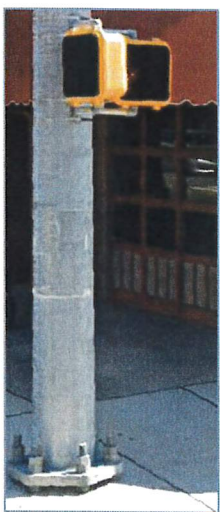
In the example below, one sign on the permit was missing from the field (see example image 1). A sign with the symbol “R” a R3-7R (Right Lane Must Turn Right) was noted on the permit. Upon inspection of the area the sign was not located as indicated. A pedestrian signal housing existed in the field but was not shown on the permit (see example image 2). The field review found that a structure had two pedestrian signal heads, instead of just one (see example image 3).

Example Image 3 -
Field showing two pedestrian signal heads

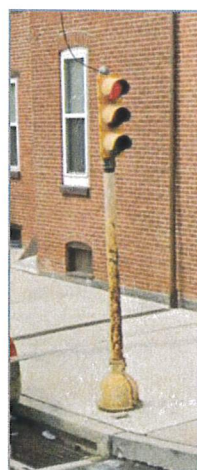
The first modification corrective action is related to the vehicle signal head lateral positioning. Three approaches to the intersection have post-mounted signal heads that are less than 2 feet from the curb (one approach shown in example image 3).

*Example Image 3 -
Signal head less than 2 feet from curb*
